# Manhole Inspection Summary

Manhole # S45K2\_002MH

Insp Date: **1/10/08 8:41 AM**

**Location** Address: **Fairhaven-pennington Alley**

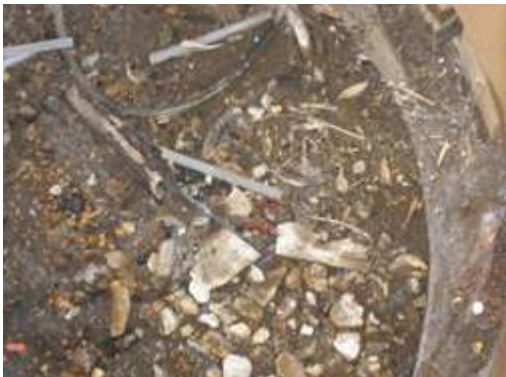
Defect 1

Condition: ☐ Sound ☐ Cracked ☐ Root Intrusion ☐ Deteriorated ☐ Leaks ☒ **Debris**

debris

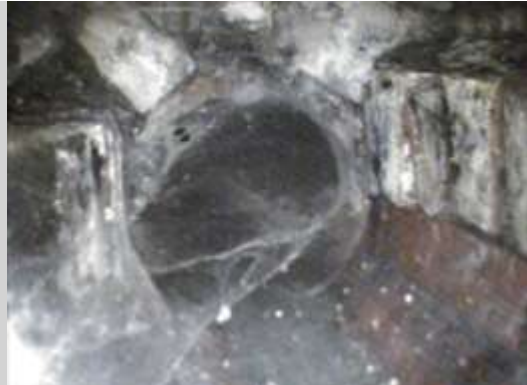
12 O'Clock Outflow

8 in. Circular Gravity Sewer  
Pipe Out @ 12 O'Clock

Pipe Height: **7.2** (in.) Rod and Bar (Angled)  
Pipe Material: **Clay** ☐ Pipe Lined  
Invert Depth: **2.96** (ft.) Flow Characteristics: **Slow**  
Deposits: ☒ None ☐ Mud ☐ Sludge ☐ Debris ☐ Grease  
Silt Depth: (in.) Deposits Extent:  
Infiltration: **None** Pipe Seal Cond: **Sound**

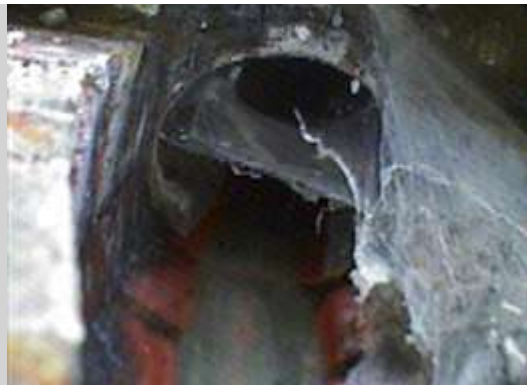
9 O'Clock Inflow

8 in. Circular Gravity Sewer  
Pipe In @ 9 O'Clock

Pipe Height: **7.2** (in.) Rod and Bar (Angled)  
Pipe Material: **Clay** ☐ Pipe Lined  
Invert Depth: **2.84** (ft.) Flow Characteristics: **Slow**  
Deposits: ☒ None ☐ Mud ☐ Sludge ☐ Debris ☐ Grease  
Silt Depth: (in.) Deposits Extent:  
Infiltration: **None** Pipe Seal Cond: **Sound**
